Manhole Inspection Summary

Manhole # S43CC_032MH

Insp Date: **12/19/07 10:15 AM**

Location Address: **arnold ct**

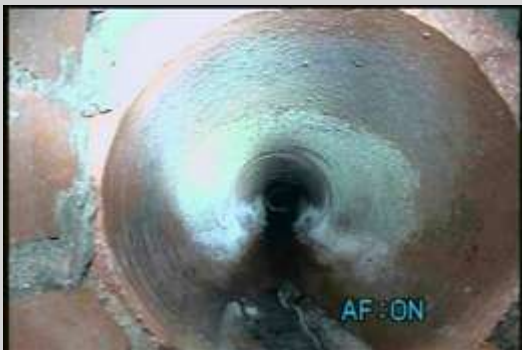
12 O'Clock Outflow

8 in. Circular Gravity Sewer
Pipe Out @ 12 O'Clock

Pipe Material: **Clay** ☐ Pipe Lined

Invert Depth: **8.20** (ft.) Flow Characteristics: **Slow**

Deposits: ☒ None ☐ Mud ☐ Sludge ☐ Debris ☐ Grease

Infiltration: **None** Pipe Seal Cond: **Unknown**

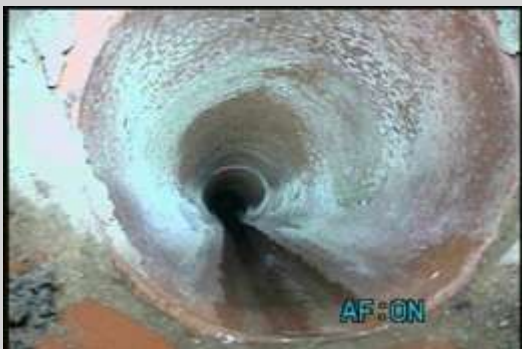
5 O'Clock Inflow

8 in. Circular Gravity Sewer
Pipe In @ 5 O'Clock

Pipe Material: **Clay** ☐ Pipe Lined

Invert Depth: **8.10** (ft.) Flow Characteristics: **Slow**

Deposits: ☒ None ☐ Mud ☐ Sludge ☐ Debris ☐ Grease

Infiltration: **None** Pipe Seal Cond: **Unknown**
